BUILDING INSPECTION REPORT

Cat 3 TC3 Rapid Assessment

Claim Number	3957849		
Policy Holder/ Contact Name	Body Corp 70946		
Address of effected Property	1-8 14 Dublin St.		
Suburb	Christchurch central		
Loss Adjuster Category	<input checked="" type="radio"/> Cat3	Cat2	Unit 1 Disabled.
Dwelling Occupied	<input checked="" type="radio"/> Yes	No	Elderly? <input checked="" type="radio"/> Yes No
Assessment Completed	Regan Hale / Houghton Side Dwelling statistics (Incl attached garage)		
Company	Simplexity	External Perimeter	66.32 m
Date	7.9.12.	Building footprint	136.03 m ²
Time	12pm.	Number of levels	3 4
		Gross floor area*	492.41 m ²
External Inspection	Yes	Approx construction date	1990's
Internal Inspection	Yes	Freestanding dwelling	<input checked="" type="radio"/> Yes No
Reason for not		*NB Outbuildings detailed on sketch plans	
		Stud height	2.4 m
Dwelling Type	<input checked="" type="radio"/> Unit / Villa / Bungalow / Townhouse / Executive / Luxury		
Quality of Fittings/	Standard / <input checked="" type="radio"/> Medium / High / Luxury

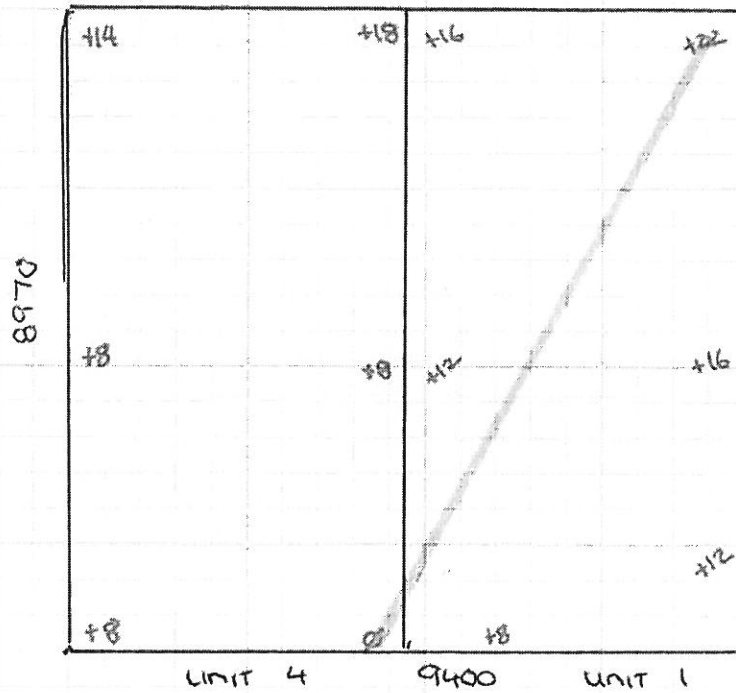
ground floor Slope in dex $\frac{22}{10000} \times 100 = 0.22\%$

Unit ① MAKE SAFE
 REQ. FRONT @ DUBLIN ST
 COURT YARD PERM SUM
 TILES & 2nd CONCRETE MUST,
 & @ REAR 2 DAYS HOTMIX
 ASPHALT. TENANT DISABLED

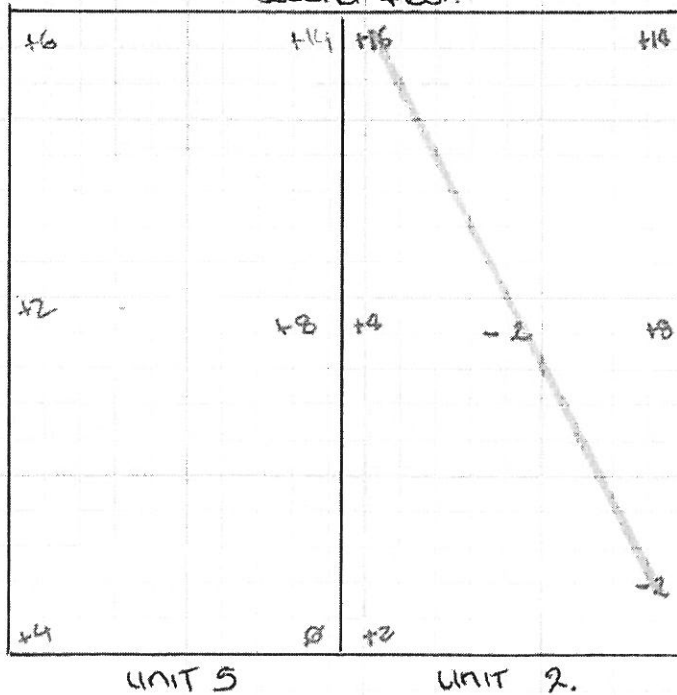
second floor.

slope index $\frac{18}{9500} \times 100 = 0.189\%$

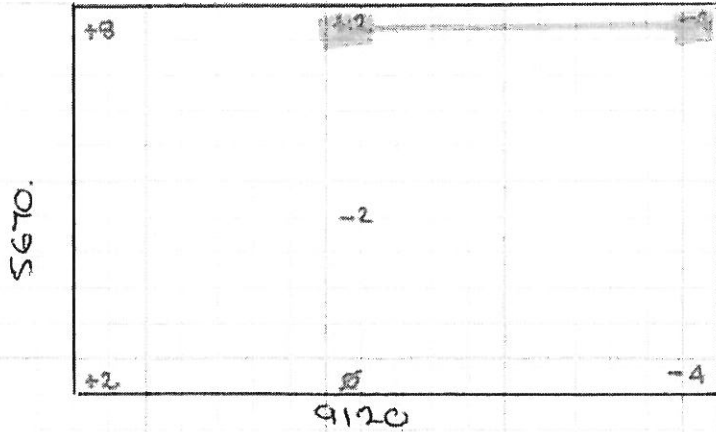
Second floor unit 7.

slope index

$$\frac{16}{5000} \times 100 = 0.32\%$$

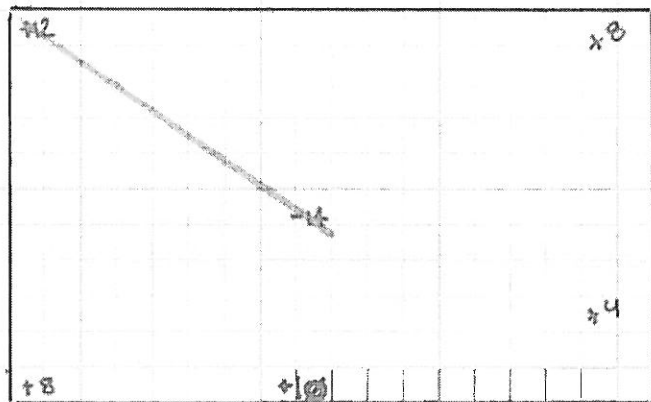
Third floor Unit 8. — Timber floor.

slope index

$$\frac{26}{5000} \times 100 = 0.52\%$$

SAME LEVEL AS ENTRY TO 5

BETWEEN 7 & 5, UNIT 5 IS 4mm LOWER @ ENTRY DOOR

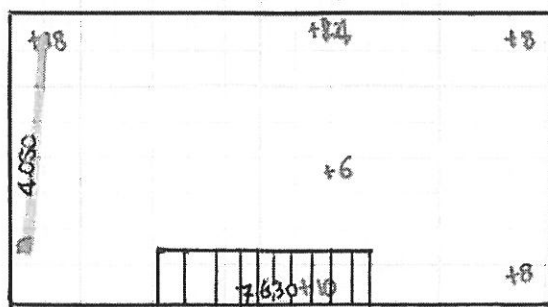
unit 6.

slope index

$$\frac{18}{3000} \times 100 = 0.60\%$$

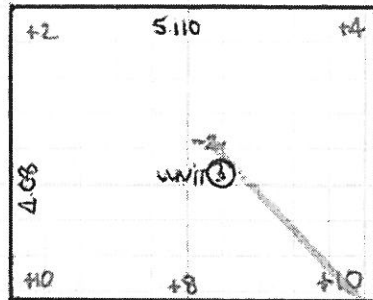
unit 3.

slope index

$$\frac{12}{3000} \times 100 = 0.40\%$$

SAME ZERO POINT AS ⑥
